# Manhole Inspection Summary

Manhole # S41G\_\_030MH

Insp Date: **11/6/08 2:03 PM**

**Location** Address: **1142 e pratt st**

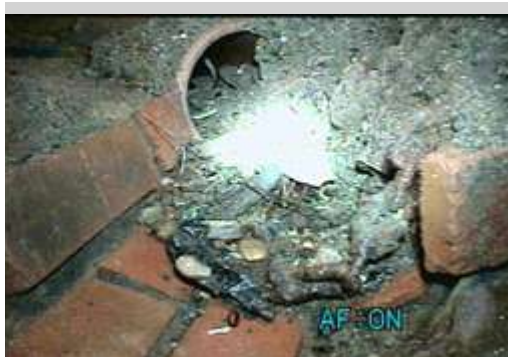
Defect 4

Condition: ☐ Sound ☐ Cracked ☐ Root Intrusion ☐ Deteriorated ☐ Leaks ☒ **Debris**

channel debris

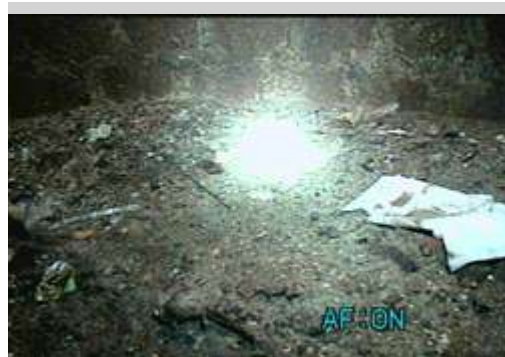
Defect 3

Condition: ☐ Sound ☐ Cracked ☐ Root Intrusion ☐ Deteriorated ☐ Leaks ☒ **Debris**

bench debris

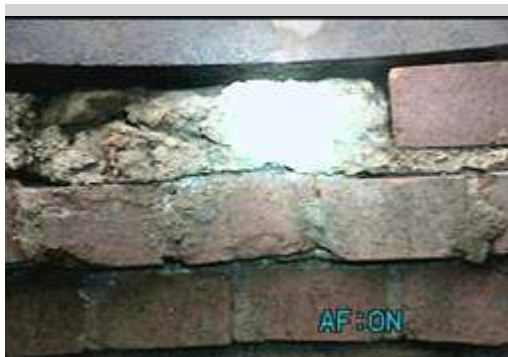
Defect 2

Condition: ☐ Sound ☒ **Cracked** ☐ Root Intrusion ☒ **Loose Brick** ☐ Deteriorated

chimney loose bricks, frame adj

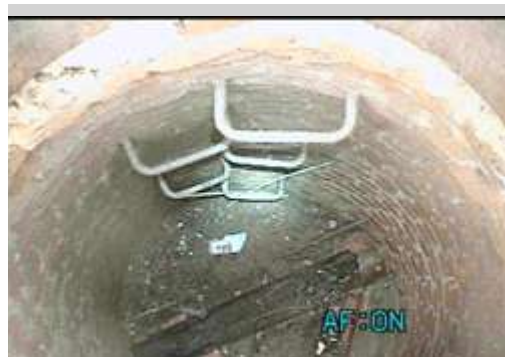
Defect 1

Count: **5** Missing: **0** ☒ **Corroded**

cor. steps

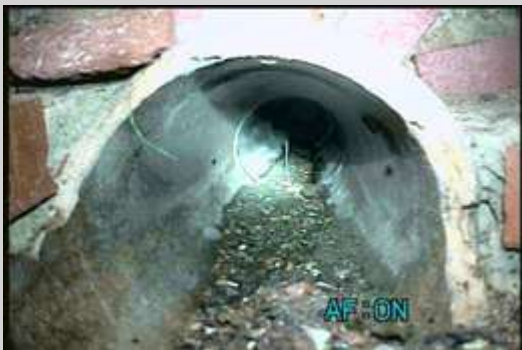
12 O'Clock Outflow

Deposits: ☐ None ☐ Mud ☐ Sludge ☒ **Debris** ☐ Grease

Silt Depth: 2 (in.) Deposits Extent: **Light**

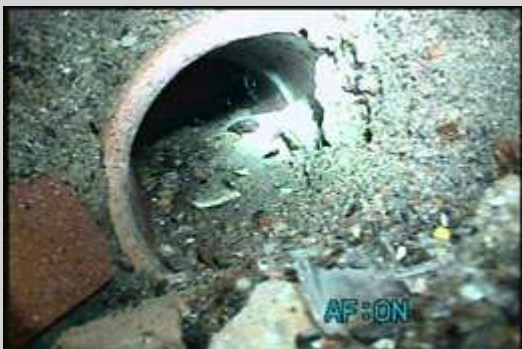
3 O'Clock Inflow

Deposits: ☐ None ☐ Mud ☐ Sludge ☒ **Debris** ☐ Grease

Silt Depth: 6 (in.) Deposits Extent: **Medium**
